WEST VIRGINIA DEPARTMENT OF TRANSPORTATION  
DIVISION OF HIGHWAYS  
MATERIALS CONTROL, SOILS AND TESTING DIVISION

MATERIALS PROCEDURE

GUIDE FOR EVALUATION OF ASPHALT  
PAVEMENTS WITH SUBSTANDARD PROPERTIES

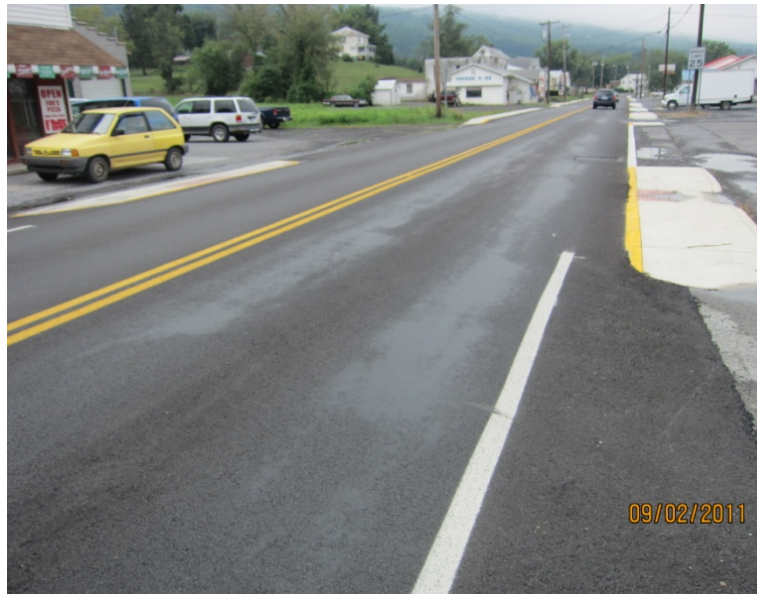
**Excessive Bleeding and Flushing along wheel paths in new asphalt pavement.**

- 10.1 *Flushing and Bleeding* occur when the liquid asphalt cement comes to the top of the mix surface generally under traffic loading and are usually in the form of long streaks or strips along the wheel paths within the mat. *Fat Spots* are more isolated areas where liquid asphalt comes to the surface of the mix, but are not necessarily concentrated in the wheel paths. They can occur anywhere across the mat and generally occur during the laydown and compaction process, and in many cases result in very thick patches of free liquid asphalt on the surface of the mat. These characteristics may result from a high AC or in-place density, low VTM or VMA, or an excessively fine gradation. These types of distresses are serious in nature and not easily addressed with remedial treatments. Pavements in this condition often eventually rut, shove, and can present numerous safety concerns.

- 10.1.1 The above defects are all indications of excess binder in the mix and should be considered for removal and replacement if the areas are large enough, occur in a pattern and affect a significant portion of the mix. Specifically, any flushing that extends more than about 30 feet in length and occurs in multiple locations as opposed to an isolated area is a cause for concern. Fat spots that are relatively small (less than approximately 12 inches in diameter) and occur only occasionally are not generally a concern. However, large fat spots (greater than 12 inches in diameter) and/or fat spots prevalent throughout the mat are a concern. The best action is to remove and replace the affected area.

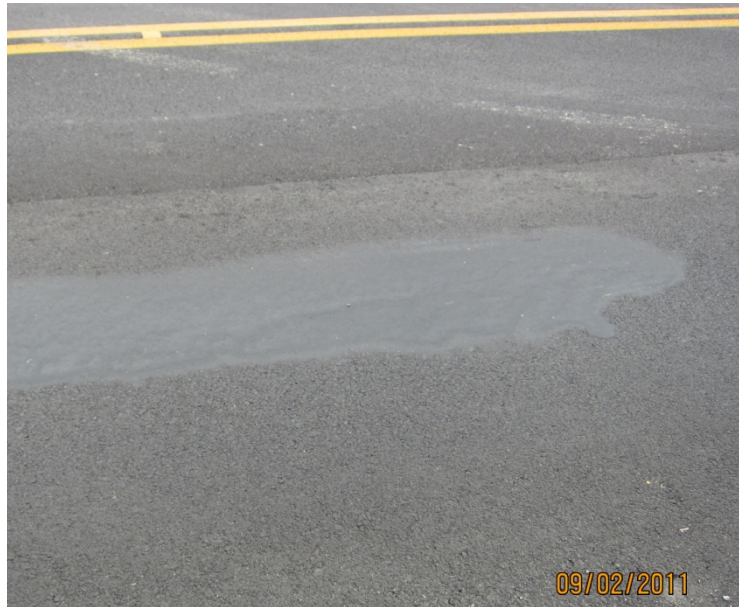
**Excessive Fat Spot in new asphalt pavement.**

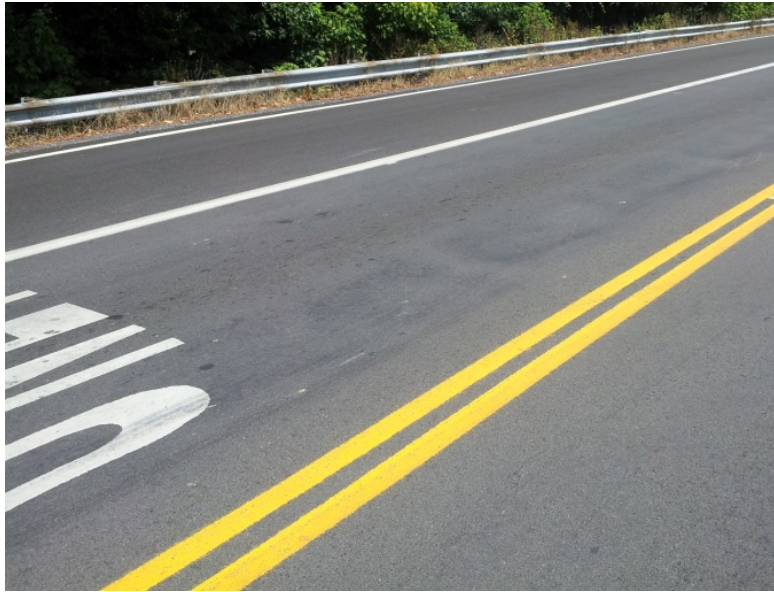
Excessive rutting and shoving in new asphalt pavement. Note the displacement of the road lettering. Also note the presence of corresponding flushing of liquid asphalt.

- 10.2 Locations of *rutting or shoving* often occur corresponding to areas exhibiting flushing and bleeding. Again, these types of distresses are serious and present numerous safety concerns. Excessively deep pavement ruts can be a significant hazard to drivers. Along with a likely decreased skid resistance to begin with, water can pond in ruts and create a potential for vehicular hydroplaning and excessive spray, which can obscure a driver's vision. Ponded water may also freeze in cold temperatures and result in the formation of ice.

- 10.2.1 Therefore, rutting that occurs within the first three months of service life and exceeds  $\frac{1}{4}$  inch may be an indication of further rutting and should be monitored further. Additionally, rutting that occurs within the first three months of service life and exceeds  $\frac{1}{2}$  inch is considered a safety hazard and remediation is required. The best action is to remove and replace the affected area.

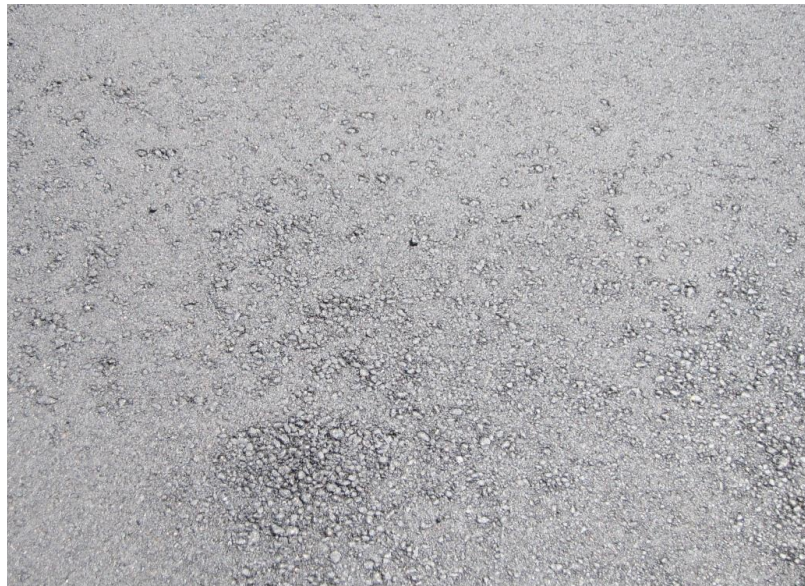
Segregation in new asphalt pavement, Superpave 9.5 mm mix.

A *segregated* mat can result from a number of factors ranging from the aggregate stockpiles at the asphalt mixing plant to the paving equipment at the project site. If segregation is widespread over several hundred feet of continuous pavement, removal and replacement of the affected area is probably the best option. When the segregated areas are discontinuous or “spotty,” removing and replacing various areas introduces a number of new construction joints. This scenario may often be less desirable than the original, segregated mat. In these cases, a fine-textured seal course is an option to consider for the affected locations.

Additional guidance on the evaluation of and severity of segregation can be found in Standard Specifications Section 410, Part 410.7.3 and use of MP 401.07.24.

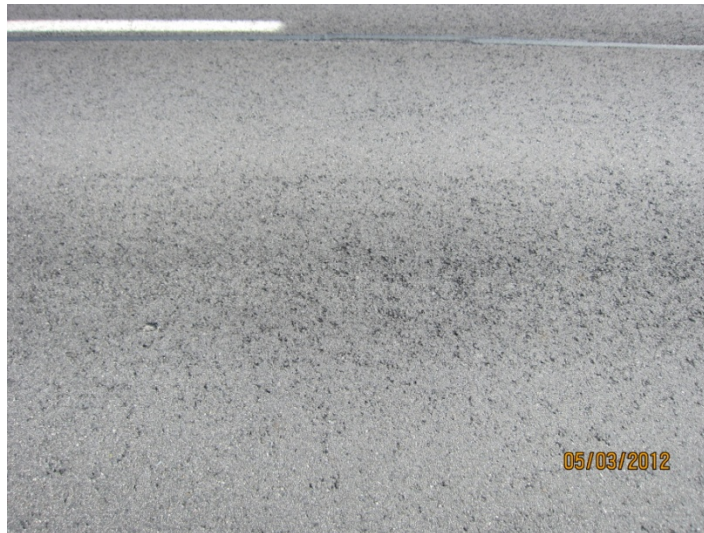
**Photo shows excessive raveling of pavement within an area of segregation during first year of service – 12.5 mm Superpave mix.**

- 10.4 *Raveling* generally begins with the loss of surface fines or smaller aggregates, and then progresses to include larger aggregates sizes. It often occurs within a segregated mat after exposure to traffic and climate. For this reason, raveling is considered serious because some amount of coated aggregate has already been lost at the pavement surface, presenting more opportunity for moisture infiltration or premature oxidation.

As with segregation, if the raveling is widespread and generally continuous, removal and replacement of the affected area is probably the best option. Excessive raveling and segregation can result in premature cracking of the asphalt pavement. However, when the raveled areas are discontinuous, removing and replacing various unconnected areas introduces a number of new construction joints. This scenario may often be less desirable than the original pavement. In these cases, a fine-textured seal course or micro surfacing may be an option to consider for the affected locations.

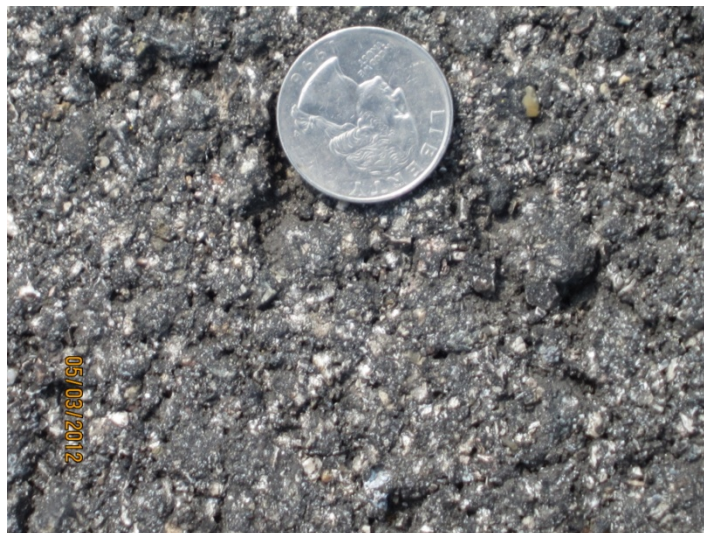
**Photo showing close view of raveling from photo above.**

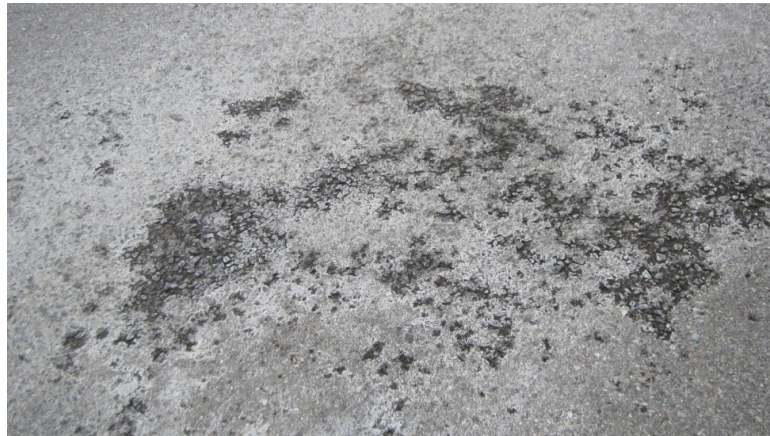
**Photo shows advanced raveling and segregation of a Superpave 12.5 mm mix.**

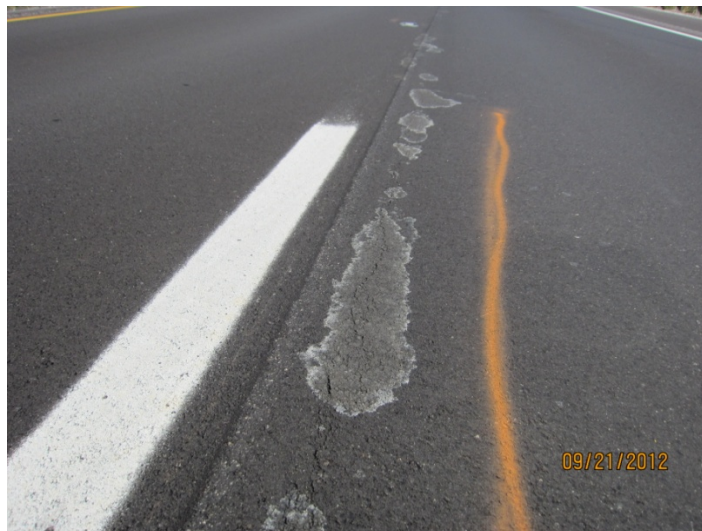
**Tear in new asphalt pavement. Note water stains along cracks.  
Area has been marked for repair.**

- 10.5      *Tearing or pulling* is another defect that can be found in newly placed mat. The mat can be torn or pulled by a paver that is traveling too fast, a paver with a screed that is worn or not heated properly, compacted by a roller that is traveling too fast or rolling a tender mix. The areas affected will have reduced density and are more susceptible to raveling and to the adverse effects of moisture. Depending on the severity of the tears, it may become a safety concern. The best option is to remove and replace the affected area.

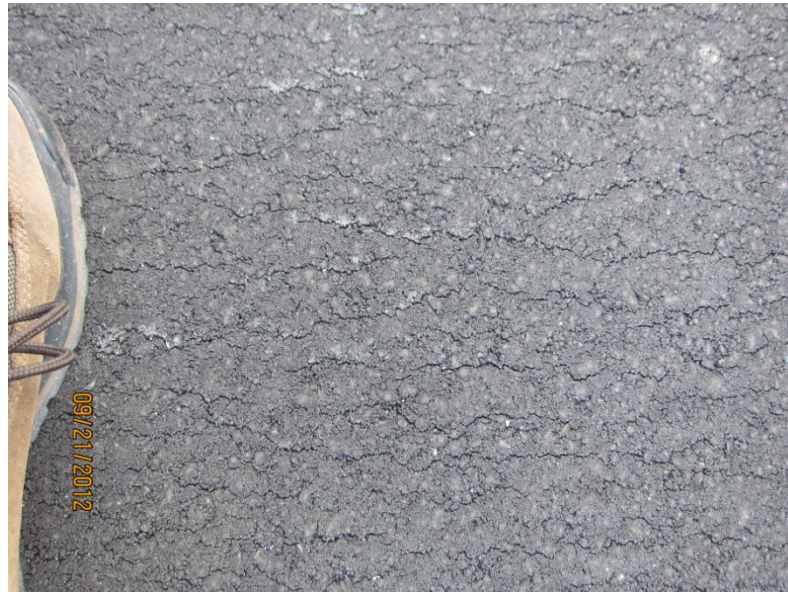
Typical observations of checking in new asphalt pavement – Superpave 9.5 mm mix.

- 10.6 *Checking* is defined as short transverse cracks, usually 1 to 3 inches in length and generally a little less than 1 inch to as much as 3 inches apart, that develop in the surface of the mat during the compaction process. Although the cracks generally extend from about 3/8 inch to 1/2 inch in depth, they are considered detrimental to long-term pavement performance. It is necessary to determine if the cause for checking is primarily mix deficiencies resulting in a tender mix, or excessive deflection in a pavement structure under the compaction equipment. Mixes that exhibit checking are a direct indication of likely insufficient density; therefore, the pavement life under traffic will likely be greatly reduced.

- 10.6.1 If it can be determined that checking is caused by the presence of a yielding foundation (such as by means of proof rolling to detect deflection or otherwise) under the new asphalt layer, the best solution is to remove and properly repair the existing pavement structure by also removal and replacement of the yielding sub-base and/or subgrade material. This work may be outside of the scope of the original contract and will need to be evaluated prior to the repair process for contractual considerations.

- 10.6.2 If checking is determined to be the result of mix characteristics only, it may also be possible to seal the course affected by use of a fine textured asphalt mix or microsurfacing course or other seal course to the satisfaction of the Engineer. Otherwise, it may be necessary to remove and replace the areas affected.

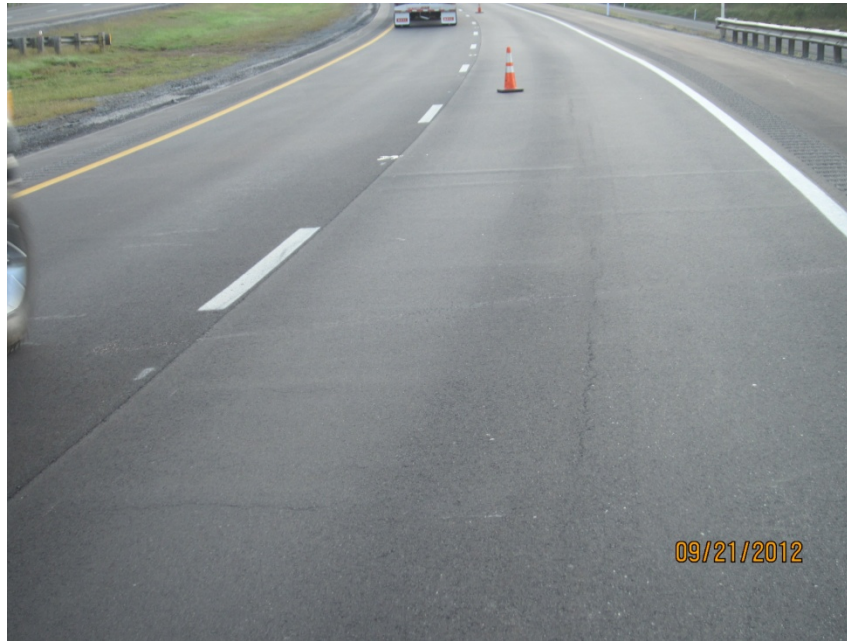
**Photo showing excessive transverse bumps and associated transverse tearing as well. This photo also shows longitudinal cracking in the center of the mat.**

- 10.7 *Bumps* in the surface may be the cause of slight shoving and transverse tearing of the pavement, and will at a minimum cause an increase in roughness. If they are bad enough that tearing is present, they can lead to other issues described above. If not torn, the pavement's structural capacity is only affected if the bumps are severe enough to cause vehicles to bounce significantly as they traverse the uneven pavement. This would increase impact loading and thus increase the overall

loading to which the pavement is subjected. In such severe cases, the likely best action is removal and replacement of the affected area.
